Advisory Bulletin 02-22-00

Aileron torque arm failure . . .

Applies only to Two Seat CGS Hawk Classics and Arrows

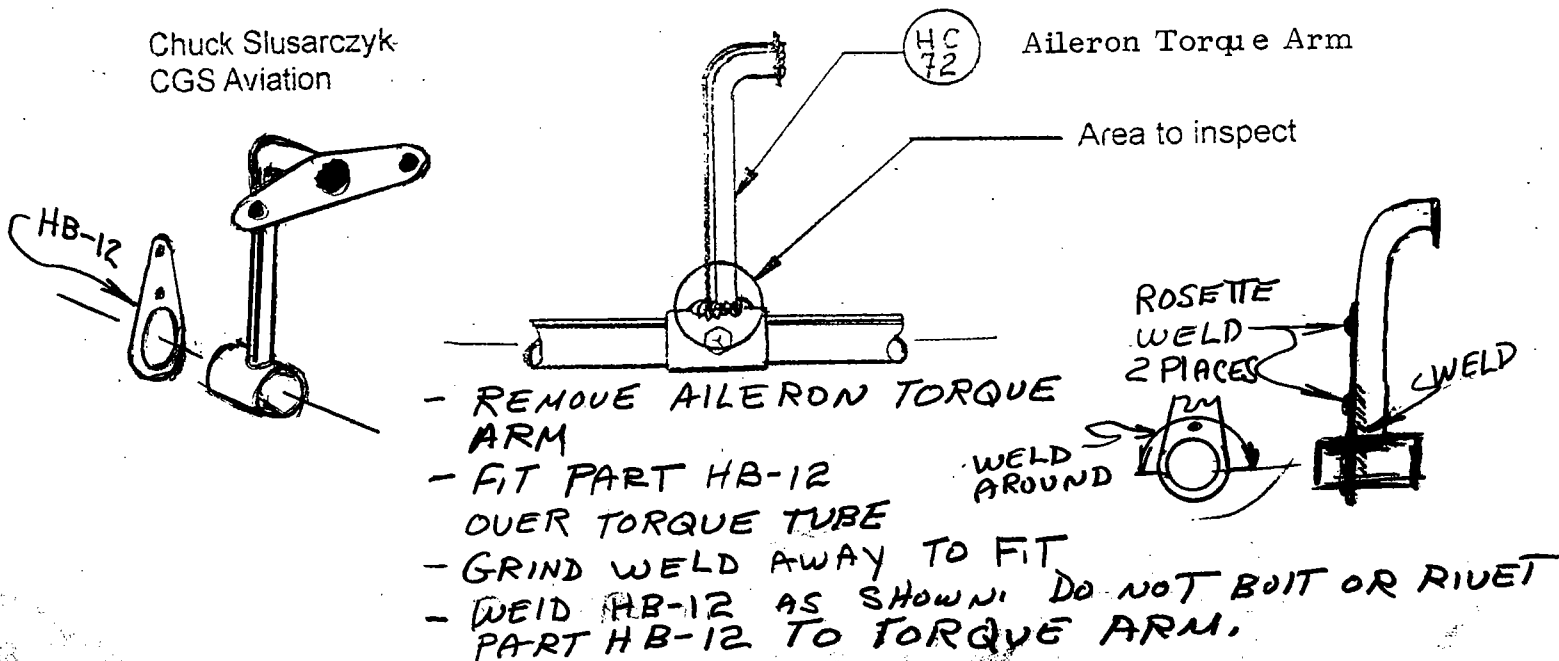
A 1996 CGS Hawk Classic Two Seat trainer experienced a failure of the aileron torque arm. The failure occurred in flight during normal operations. The pilot was able to execute a safe landing, there were no injuries or further damage. After landing the previous owner flew the plane back to the home field using rudder, elevator controls and flaps. An inspection of the failed part showed that the fracture was not sudden, but started as a small crack adjacent to the weld. The crack slowly enlarged over time until the remaining portion failed.

This plane has had many hours of dual instruction logged and has been used as a training ship since new. Because this is the one and only failure of this type since 1984 when this model was introduced it is difficult to assess the cause. It is not known if the part may have been previously damaged by someone entering or exiting the plane, or if there was a faulty weld, etc. No probable cause has been determined.

We would advise all owners of Two Seat CGS Hawk Classics and Arrows to inspect the welded area where the 1/2" tube mates with the 1 1/8" tubing looking for any abnormalities. If any are found contact CGS Aviation immediately. In an effort to prevent this from occurring again, CGS is currently testing a reinforcement to the torque arm. New Two Seat CGS Hawk Classics and Arrows will have this reinforced torque arm installed. Those who would like to have this reinforcement added to an existing Two Seat CGS Hawk Classic or Arrow contact CGS for details on a retro fit.
